## XC2200H Derivatives

16/32-Bit Single-Chip Microcontroller  
with 32-Bit Performance  
XC2000 Family / High Line

Errata Sheet

V1.6 2013-03

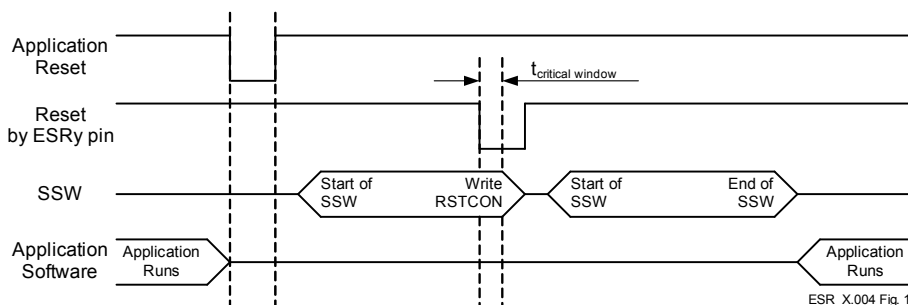
**Figure 1 Critical application reset sequence**

SCU\_RSTCONx registers are reset only by Power-On, but they may be wrongly affected after a second application reset requested by an ESRy pin. This may lead to the SCU\_RSTCONx register values being set to zero, which could unexpectedly disable reset sources within the user application. The conditions which lead to this behavior are:

1. First, an application reset by SW (software), CPU (Central Processing Unit), MP (Memory), WDT (Watchdog Timer) or ESRy (External Service Request y) occurs.
2. Following this, an application reset on an ESRy pin occurs.
3. If the above mentioned ESRy reset occurs during a critical time window of the SSW (startup software), then it's possible that the application will operate with the wrong SCU\_RSTCONx register value. The critical time window occurs when the SSW is writing the SCU\_RSTCONx registers, and at the same time, the ESRy reset request is processed by the reset circuitry. The width of this critical window  $t_{\text{critical window}}$  is less than 13 cycles.

### **Workaround**

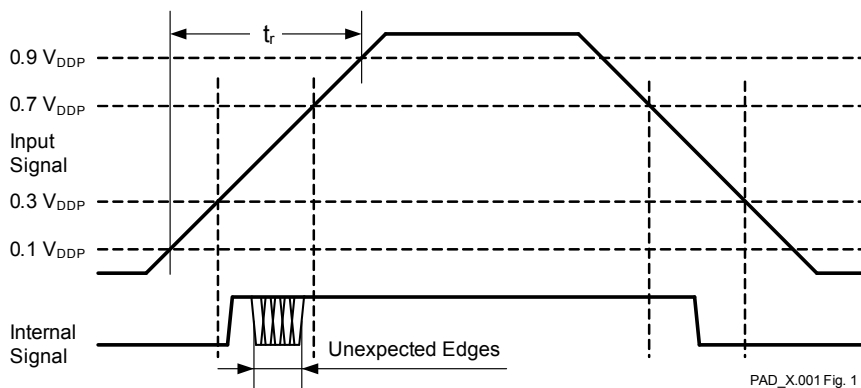
**Figure 2** Example for a Slow Input Signal

The digital input- and I/O-pins are designed using Schmitt trigger input structures with hysteresis. Even with this structure, it is possible that very slow rising edges may generate spikes, resulting in unexpected additional edges at the input signal.

The next picture **Figure 2** is an example for a slow input signal, with spikes shown on the slow rising input signal.

The first rising edge in **Figure 2** of the internal signal is always valid. The edges which are marked with “Unexpected Edges” must be ignored.

## **Workaround for Input Capture Conditions**

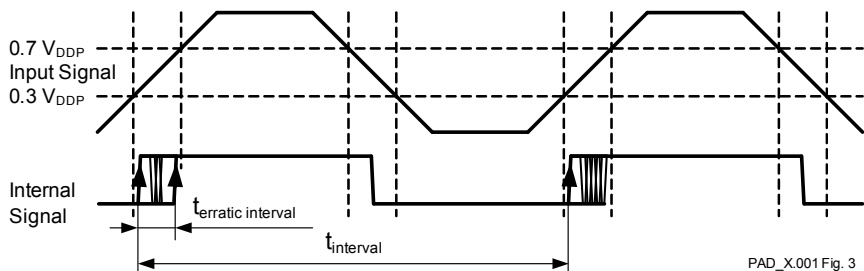
**Figure 4 Rising Edge Detection Approach**

In case of rising edge detection multiple interrupts would be generated when the spike occurs. The time interval since the last interrupt can be measured – if it is very small compared to the expected value, this would indicate a spike and the interrupt should be ignored.

If the time between the rising signal edge and the rising edge caused by a spike  $t_{erratic}$  is less than the ISR service time, a workaround would be to clear the

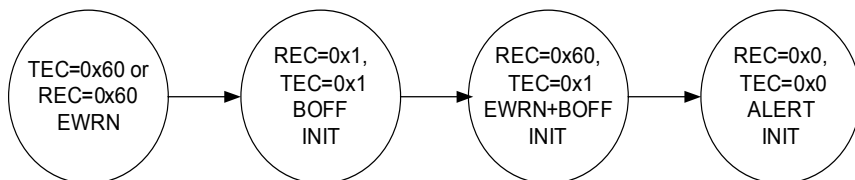
**Figure 6 Alert Interrupt Behavior in case of Bus-Off**

The MultiCAN module shows the following behavior in case of a bus-off status:

When the threshold for error warning (EWRN) is reached (default value of Error Warning Level EWRN = 0x60), then the EWRN interrupt is issued. The bus-off (BOFF) status is reached if TEC > 255 according to CAN specification, changing the MultiCAN module with REC and TEC to the same value 0x1, setting the INIT bit to 1<sub>B</sub>, and issuing the BOFF interrupt. The bus-off recovery phase starts automatically. Every time an idle time is seen, REC is incremented. If REC = 0x60, a combined status EWRN+BOFF is reached. The corresponding interrupt can also be seen as a pre-warning interrupt, that the bus-off recovery phase will be finished soon. When the bus-off recovery phase has finished (128 times idle time have been seen on the bus), EWRN and BOFF are cleared, the ALERT interrupt bit is set and the INIT bit is still set.

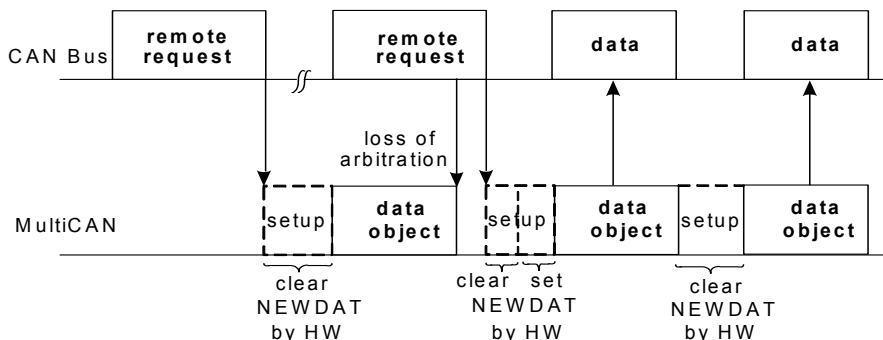
**Figure 7 Loss of Arbitration**

When the appropriate message object (data frame) triggered by the first remote frame wins the arbitration, it will be sent out and `NEWDAT` is not reset. This leads to an additional data frame, that will be sent by this message object (clearing `NEWDAT`).

There will, however, not be more data frames than there are corresponding remote requests.
